Conference Paper · October 2023

SECED 2023 Conference
Earthquake Engineering & Dynamics for a Sustainable Future
14-15 September 2023, Cambridge, UK

HYBRID EEFIT MISSION TO FEBRUARY 2023 KAHRAMANMARAŞ EARTHQUAKE SEQUENCE

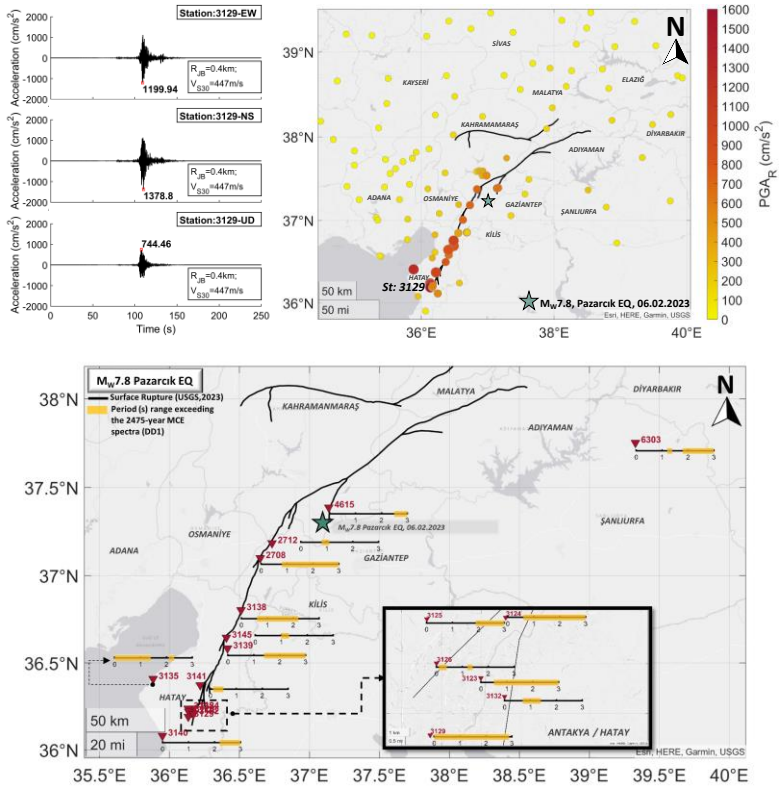
ground motions in one of the Antakya basin stations ($PGA_{3125,EW}$≈769 cm/s^2) as well. In M_W7.5 Elbistan event, which predominantly impacts the region's north, the closest station to the fault rupture (station 4612) produces 636 cm/s^2 in the East-West component. Due to the extensive rupture length of particularly M_W7.8 and M_W7.5 events (350–400 km in the case of the M_W7.8 earthquake and 150–200 km in the case of the Mw7.5 earthquakes), the Joyner–Boore distance (R_{JB}), which is defined as the closest horizontal distance to the vertical projection of the rupture surface, yields more meaningful evaluation. The stations positioned nearby the fault ruptures (small R_{JB}s) give significant PGA values as exemplified for the M_W7.8 event in Figure 1(top).

Figure 1. (top) Geographic distribution of resultant peak ground accelerations (PGA_Rs) with respect for M_W7.8 Pazarcık event (bottom) Geographic distribution of stations with period ranges of exceedances of MCE level design spectra of 2018 Türkiye building earthquake code (TBEC 2018) for M_W7.8 Pazarcık event. (black lines on the maps correspond to the surface rupture given by USGS).

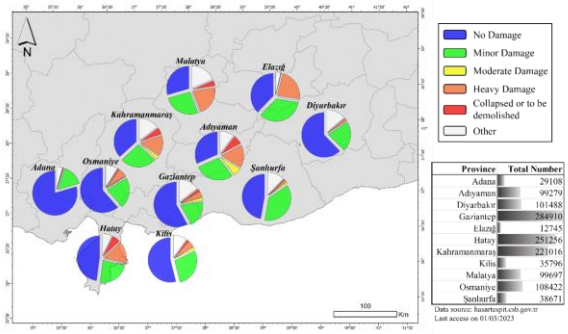
Before the field mission, (social) media and other web-based data sources and remote sensing products were used to gather preliminary information and effectively plan site visits. As part of the pre-fieldwork studies, the EEFIT team also assessed the damage dataset provided by Türkiye's Ministry of Environment, Urbanisation, and Climate Change (TMoEUCC). This extensive undertaking involved a team of over 7,000 experts, primarily comprising the ministry's technical staff, engineers representing vocational chambers, and academics. The Ministry's public dataset, accessed through hasartespit.csb.gov.tr, was last updated on March 1, 2023. Figure 3 illustrates the damage state per province, involving a total of over 1.28M buildings. Hatay, Kahramanmaraş, Adıyaman, and Elazığ were provinces with the highest proportion of collapses and heavy damage. Considering the seismotectonic characteristics of the sequence, it is seen that the structural damage was concentrated within/around the fault ruptures of the two MW7+ events.

Figure 3. Distribution of damage in the 11 provinces within the disaster region as per the damage assessment data by the TMoEUCC as of 1 March.

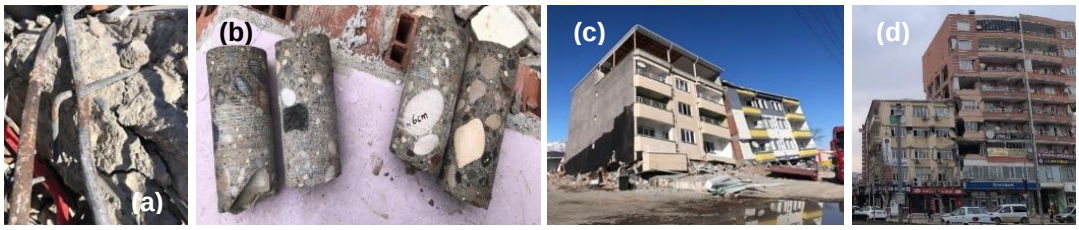
zoning amnesties have made pre-2000 RC buildings the most vulnerable group in the building stock. Consequently, these buildings suffered from problems such as inadequate reinforcement, abnormal granulometry in concrete, design issues like short column effects, soft/weak stories, pounding effects, and soil-structure problems (Figure 4).

Figure 4. Damage representations from the earthquake-affected cities (a) Plain round rebars and 90° hooks at the end of stirrups, (b) Abnormal granulometry, (c) Soft/weak story, and (d) Pounding effects

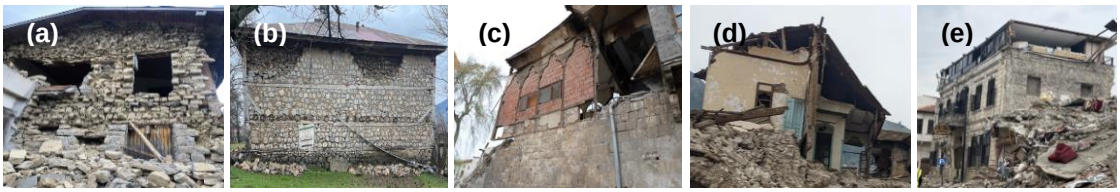
Traditional Buildings: Traditional buildings typically have 1-3 stories and can be classified into three categories: (1) Unreinforced Masonry load-bearing walls (URM), (2) Timber reinforced masonry; and (3) ***Hımış***, a hybrid typology combining masonry ground floor, and wooden framed upper floors with masonry infill or cladding (Aktas, 2017). In big cities, these typologies are more often built with cut or irregular stones using lime mortar, while villages commonly used earth blocks and local stones with mud mortar. Many village houses lack regular maintenance. They exhibit a wide range of flooring options, including timber flooring, masonry vaults, and reinforced concrete (RC) slabs, and supported by steel I beams. One of the major failures observed in URM is the loss of integrity in the wall leaf composed of irregular stones. These issues can lead to various types of failures, which include roof collapse, localised out-of-plane (OOP) failure of individual spandrels and piers, global OOP failure of entire façade, failure at corners, separation of quoins that are unable to strengthen the connections between walls and failure of the gable. Alterations, such as adding extra floors or replacing original floors with heavier RC slabs, were observed to result in failures of entire floors or roofs, as evidenced by on-site observations. Pounding is commonly observed in traditional structures with varying heights, constructed using different structural systems, and at different times (Figure 5).

Figure 5: (a) URM (separation wall-leaf); (b) timber reinforced stone masonry (arch failure); (c) Hımış (OOP of bearing wall), (d) gable failure, and (e) addition of a storey

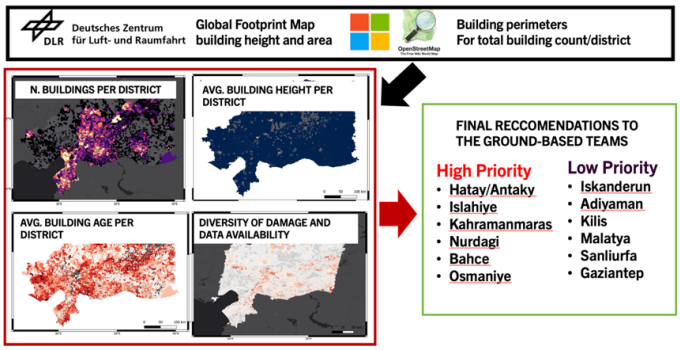
Figure 8. Actionable products generated for delineating the top six high and low priority areas for the EEFIT Türkiye remote sensing mission.

The activities of the RS team resulted in the identification of six high-priority areas where a variety of buildings are located and are highly diversified by height, building age and spaceborne damage maps (Figure 8). These six high-priority AOIs are: Hatay/Antakya, Islahiye, Kahramanmaraş, Nurdağı, Bahçe, and Osmaniye. Additionally, the team was asked to produce a list of six low-priority AOI that presented a lower diversity of damage and building characteristics. These low-priority AOIs are located close to the six high-priority areas and could simplify the logistics of the ground-based team.
